Recent developments in vibration analysis of historic and masonry structures: damage detection and wireless sensor networks

ABSTRACT: Preservation of architectural heritage is considered a fundamental issue in the cultural life of modern societies. This heritage is accumulating damage due to deterioration of materials, repeated loading and exceptional events. This means that conservation, repair and strengthening are often necessary. In this process, monitoring and non-destructive testing play a major role, providing information on the building condition and existing damage, and allowing to define adequate remedial measures. Dynamic based methods are an attractive tool because they are non-destructive and are able to capture the global structural behaviour. The present paper focuses on different aspects related to vibration analysis, namely exploring damage, environmental effects on the dynamic response, a comparison between commercial wireless based platforms and conventional wired based systems, and a novel wireless based system.

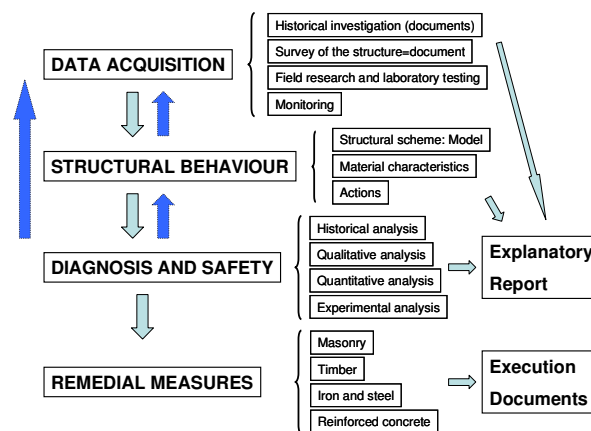
Figure 1: Possible flow-chart for ICOMOS Methodology.

A multi-disciplinary approach is required and the peculiarity of heritage structures, with their complex history, requires the organization of studies and analysis in steps: condition survey, identification of the causes of damage and decay, choice of the remedial measures and control of the efficiency of the interventions. Understanding of the structural behaviour and material characteristics is essential for any project related to architectural heritage. Diagnosis is based on historical information and qualitative and quantitative approaches. The qualitative approach is based on direct observation of the structural damage and material decay as well as historical and archaeological research, while the quantitative approach requires material and structural tests, monitoring and structural analysis, see Figure 1.

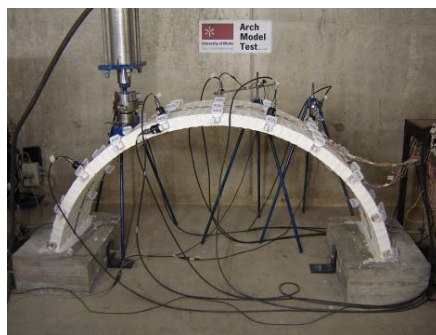
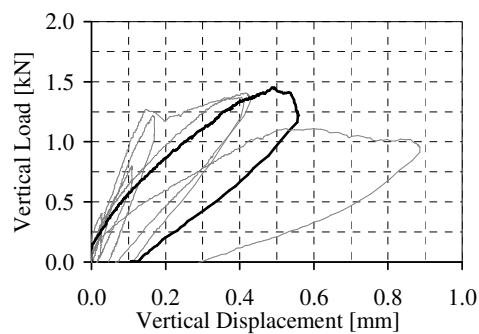
Figure 2: Arch static tests: (a) view of the test apparatus; (b) example of one damage scenario considered.

One replica of an old masonry arch was built in the laboratory and several controlled Damage Scenarios (DS) were induced with static tests, see Figure 2. For each DS, system identification tests were carried out with SSI techniques, Peeters (2000), and the results of the damage identification methods were compared with the internal crack growth. The ambient temperature and humidity were also recorded, to evaluate possible environmental effects on the dynamic response.

Figure 2b shows the response of the model during the successive static tests after the first crack, and one selected damage scenario. The tests results in terms of load displacement diagrams indicate a clear loss of stiffness upon reloading, with visible load drops due to crack opening. Figure 3 presents the resulting crack patterns in the arch and the position of the dynamic transducers. Four cracks were found but it was impossible to register the full crack sequence. The first crack to appear (*c*₁) was located between the positions P3 and P4 (accelerometers A03 and A04) and not below the load application point. The crack appears in the intrados, as expected, but it was only visible during the loading branch of the DSVI, although it is evident that it has occurred on DSV, given the loss of stiffness in the static tests.

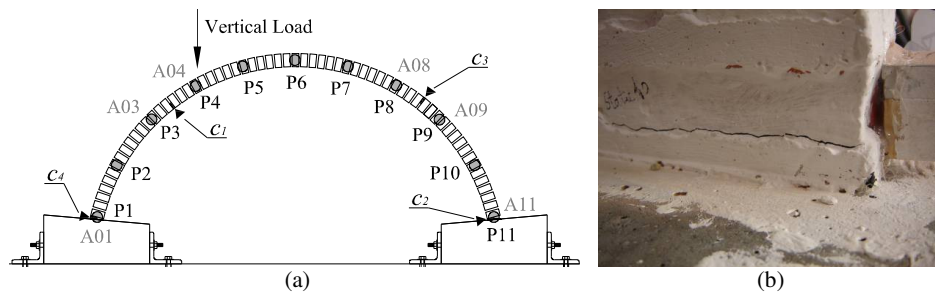
Figure 3: Arch static tests: (a) view of the test apparatus; (b) example of one damage scenario considered.

Crack *c*₂ was located in position P11 (right support in the measuring point A11) in the intrados, crack *c*₃ was located between P8 and P9 (measuring point A08 and A09) in the extrados, and crack *c*₄ was located at position P1 (left support in the measuring point A01) in the extrados, see Figure 3. The load value corresponding to the occurrence of these cracks was impossible to detect. The cracks became visible in the loading range of DSVIII. This can be explained by the fact that the self-weight of the arch is a stabilizing action and almost fully closes the cracks at the equilibrium position. The decision to stop each static test after DSV was based on the sound of a crack that suddenly opens. Therefore, the designation *c*₁ to *c*₄ presented here does not try to represent the real crack sequence, which is partly unknown.

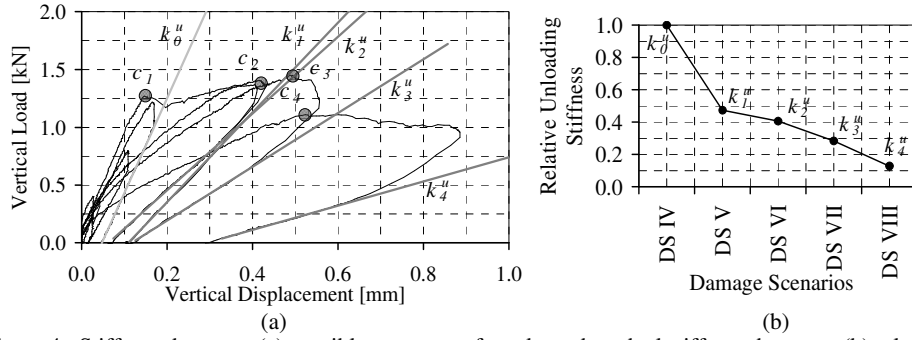
Figure 4: Stiffness decrease: (a) possible sequence of cracks and gradual stiffness decrease; (b) relative unloading stiffness variation.

It should be stressed that the maximum remaining crack opening after the entire testing program was 0.05 mm and the maximum crack depth in the loading branch of the tests was 30 mm (more than half of the arch thickness) for crack *c*₁. Analyzing in detail the stiffness during the several load steps presented in Figure 4, after the occurrence of the crack *c*₁ it was possible to observe a decrease of stiffness. A loading and unloading stiffness can be defined, as static tests allow measuring the rapidly varying loading stiffness *k*_{*l*} and the dynamic tests only measure the slowly varying unloading stiffness *k*_{*u*}. As a result, dynamic tests are less sensitive than static tests to identify structural damage.

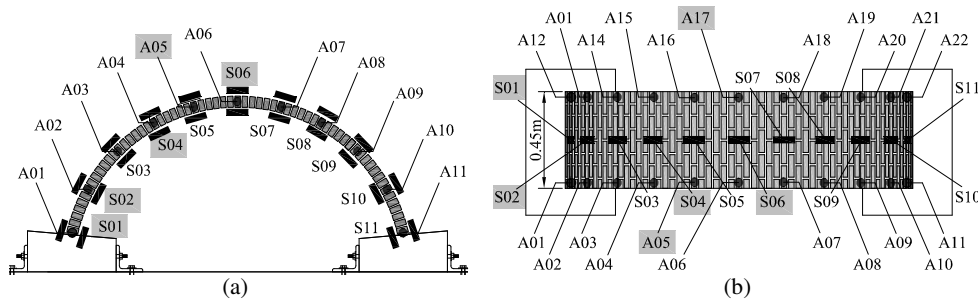
Figure 5: Location of the measuring points for the dynamic tests: (a) front view; and (b) top view. Ai indicates accelerometers and Si indicates strain gauges. Boxed-values in grey are the reference points.

The selected sensors for the dynamic tests were accelerometers and strain gauges. It was decided to measure accelerations only in the in-plane direction, and, for convenience, in the normal and tangential directions on each location. It was also decided to measure both edges of the arch (front and back edges) to estimate the torsion modes and to detect any asymmetric behaviour. Figure 5 shows the location of the measuring points where the reference points are given in a grey box. The designation Ai is for accelerometers and Si is for strain gauges. In the case of the strain gauges, as an attempt to study the possibility to measure strains for dynamic modal analysis, it was decided to measure only the middle line of the arch on both sides. This means that the torsion modes will not be present in the strains measurements.

The dynamic acquisition system was composed by 8 uniaxial piezoelectric accelerometers and 22 strain gauges glued in the masonry. Modal identification tests at each load stage/DS were carried out by two different excitation types: (a) natural and ambient noise present in the laboratory; (b) random impact excitation in space and in time (not recorded), induced by a hammer with 2.5 kg of mass. The results in terms of frequency values and damping coefficients for the Reference Scenario (RS) are presented in Table 1 for the ambient and random excitation tests, respectively. Both standard deviation (σ) and Coefficient of Variation (CV) are presented for the same modal parameters: frequency ω and damping ξ . In general, the random impact excitation tests have lower standard deviation values, indicating a possible better modal estimation. The high CV values for the damping in all cases should be stressed as possible less accurate results. The damping values depend on the excitation and incorporate nonlinear phenomena, but one can conclude that an average value of 0.6% can be observed for all modes and all analyses.

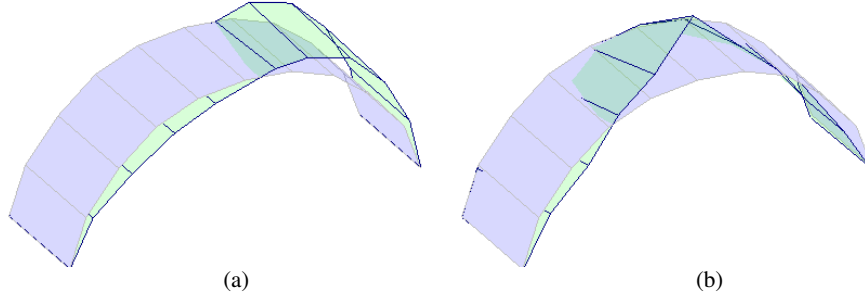
Figure 6: First mode shape configurations for the undamaged scenarios: (a) mode 1; (b) mode 2.

The first modes shapes according to the excitation type are presented in Figure 6, see Ramos *et al.* (2010a) for more results. All the modes have torsion components, with the exception of the first mode, which has only components in the arch plan. It is stressed that the modes from the two excitation types are highly coincident, with the exception for the modal configuration of the seventh mode shape at middle span and at the left support.

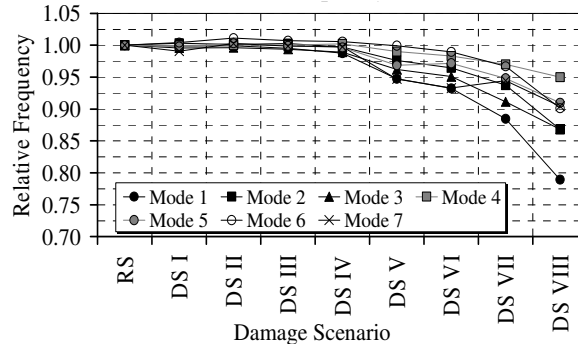
Figure 7 : Relative frequency values for ambient excitation.

Figure 7 presents the variation for the frequency, where it is noticeable that damage was detected in DSV and it is coincident with the significant decrease observed in the static results.

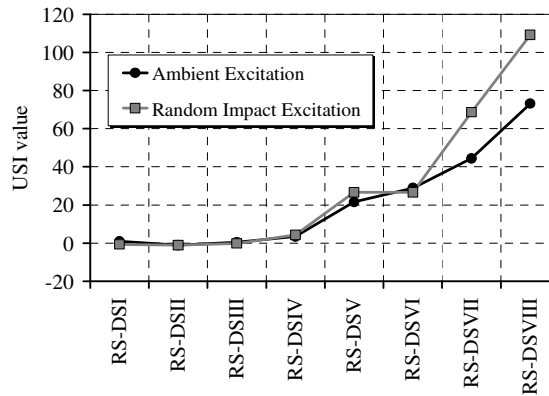
Figure 8: Unified Significance Indicator (USI) results and comparison with the RS.

As a Level 1 approach, the results of the USI method presented in Figure 8 shows the comparison with the RS. One conclusion is the difference in the order of values before and after DSV, confirming the significant change that happened in this scenario. The USI values in DSVI are similar to DSV but the last two DS show a significant increase. These results indicate that when the USI is calculated for the several scenarios, the detection of damage (Level 1) is possible. When no information exists about the modal history, the detection of damage with USI might be difficult, because there are no reference values in the undamaged condition.

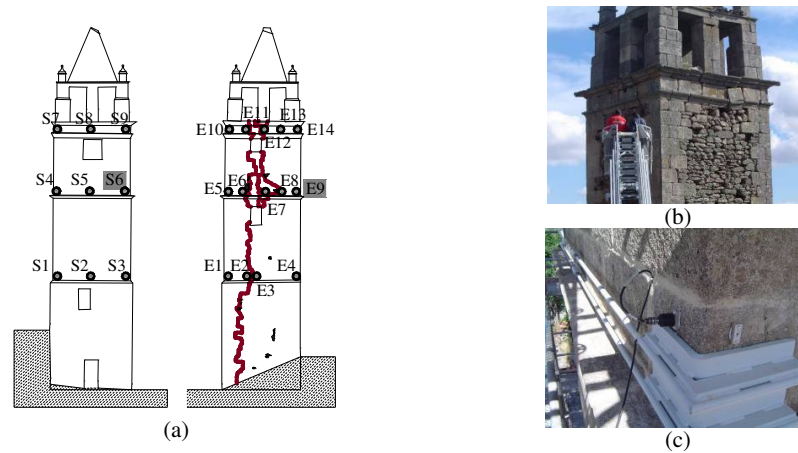
Figure 9: Dynamic tests and examples of sensor locations: (a) crack pattern and measuring points in the South and East façades, respectively; measurements (b) before and (c) after rehabilitation works.

Dynamic modal identification tests were performed before and after the works, see Figure 9. The same test planning was adopted in the two conditions by using the same measuring points. Table 3 presents the first seven estimated natural frequencies and damping ratios, see Ramos *et al.* (2010b) for more details. An analysis of the two structural conditions shows that, on average, the frequencies increased 50% with the works, while the damping decreased 40%. Concerning the modal displacements, local protuberances could be observed in the areas close to the cracks and in the upper part of the tower, before the works. This is due to the presence of severe damage. On the contrary, the structure behaves monolithically after the conservation works.

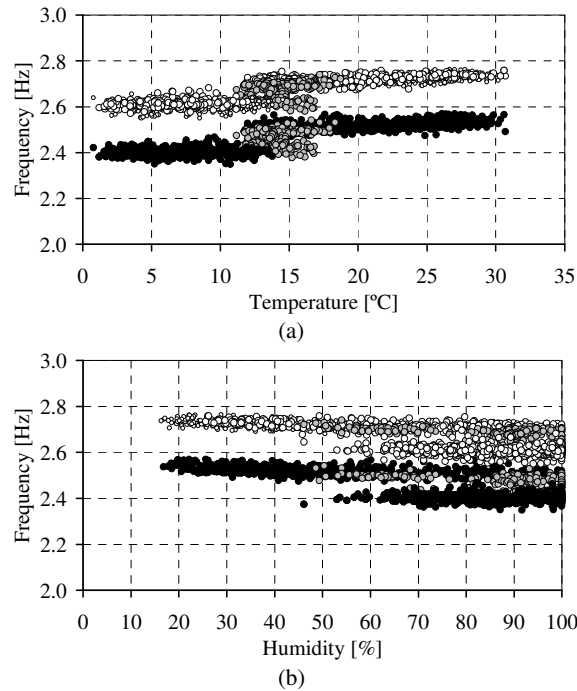
Figure 10: Environmental effects: (a) temperature; (b) relative air humidity.
Note: Black dots correspond to the first frequency, white dots to the second frequency, and grey dots to the transition period of each frequency.

The challenge now is to verify if the cracks were stabilized with the intervention by means of a dynamic monitoring system. During 2006 and 2007, and after the conservation works, a dynamic monitoring system was installed in the tower. Three piezoelectric accelerometers connected to an USB data acquisition card recorded each hour ten minutes of ambient vibrations. In parallel a combined sensor recorded the ambient temperature and relative air humidity. This task was performed in several campaigns (test series), in different periods of the year. The data series were analyzed and they allowed concluding that the environmental effects significantly change the dynamic response of the structure. Mainly, the water absorption of the

walls in the beginning of the raining seasons changes the frequencies about 4%. The significant influence of moisture inside the walls on the dynamic response of masonry structures is not reported in literature, as the changes are always attributed to others environmental effects or loading conditions, such as temperature and excitation level. The series presented in Figure 10 were recorded during October and November, 2006, which is linked to the first strong raining event at the site. As no damage was observed in the structure, the humidity influence can be observed by a shift in the linear relation between frequency and temperature by a transition series.

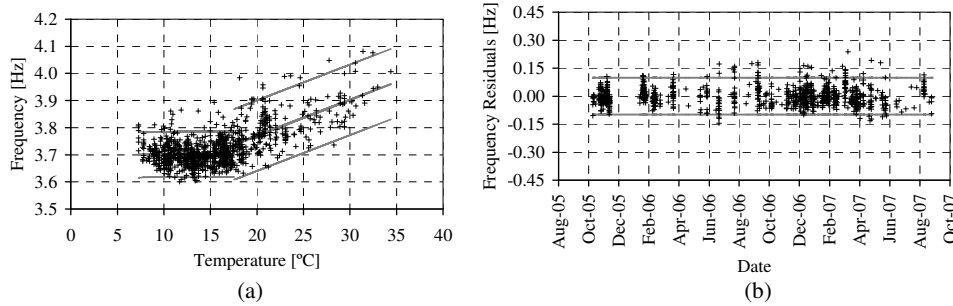
Figure 11: Static regression for the first mode: (a) temperature influence; (b) residuals history.

To estimate the modal parameters, the procedure described previously for the Mogadouro Clock Tower was again adopted. The majority of the triggered events occurred during working hours, due to the road traffic, special events inside the church (like mass or concerts), and minor earthquakes. The results indicate that the temperature effect is significant for the nave. A trend for a bilinear relation between temperature and frequency was found, with an apex for a temperature about 18°C. This trend occurs for all the estimated frequencies. As no continuum series were recorded in the monitoring system, modelling of thermal inertia is difficult and only static regression models were used. From the observed bilinear trend, two linear regressions for temperature values lower and higher than 17.5°C were adopted. Figure 11a shows the static models for the first estimated frequency by correlating the two quantities, temperature and

frequency with the 95% ($\pm 2\sigma$) confidence intervals. The results show that the bilinear static model follows the evolution of the frequencies but a significant number of outliers can be observed in Figure 11b, where the residuals between the first natural frequency and the simulated frequency are shown. This indicates that others environmental effects need to be studied to better model the dynamic response.

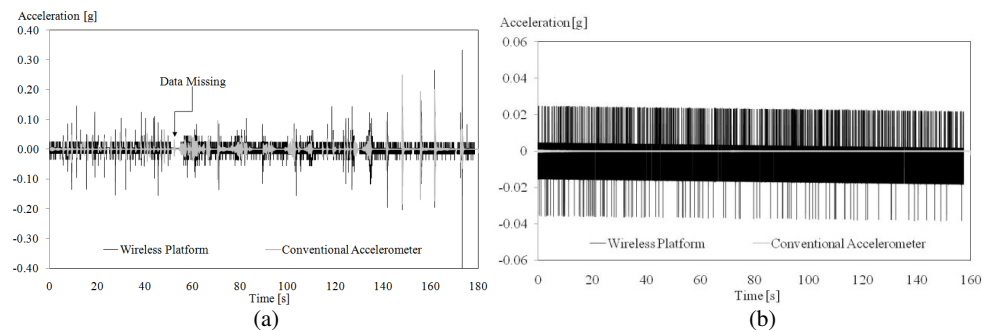
Figure 12: Time series collected by mote 3 and accelerometer 3 in the inverted pendulum tests: (a) response under random excitation in Setup 01; (b) response under ambient noise in Setup 02.

MEMS sensors were programmed to perform measurements only in one axis). For comparison purposes the wired and wireless systems were set to run concurrently. Initially, the performance with respect to an acceleration time series was studied using tests under random excitation and ambient noise. Figure 12 shows the recorded signal by mote 3 and accelerometer 3 in both scenarios. The results demonstrate the poor performance of the micro-accelerometers for measuring low amplitude vibrations. The maximum values and the root mean square (RMS) registered by the wireless platforms are, respectively, 3 to 6 times and 8 to 22 times lower than the values recorded by the conventional platforms with ambient noise. Similar results were obtained in the case of the RMS in random excitation, even if the time series recorded with both systems are rather similar.

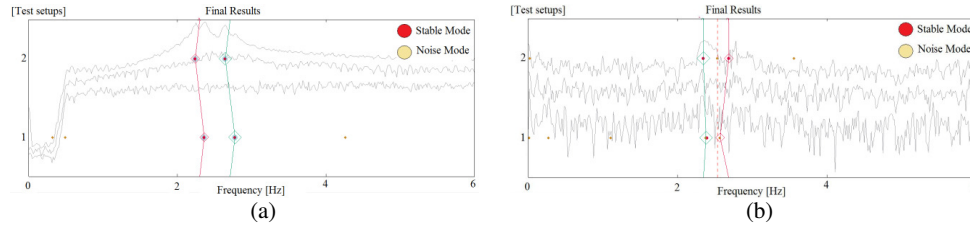
Figure 13: Stabilization diagrams for the analysis of the time series recorded under random excitation in the inverted pendulum tests: (a) results of the conventional wired based accelerometers; (b) results of the wireless platforms.

Then, the dynamic characteristics of the system were studied. For this purpose, the SSI-Data method implemented in the ARTeMIS extractor software was used. Figure 13 shows the stabilization diagram corresponding to the random excitation and Table 6 shows a summary of the results accelerometers, where f is the frequency and ξ is the damping. According to the frequency content results, the wireless based platforms give accurate results (errors of about 2% for random excitation and about 7% for ambient vibration). When the structure is lightly and randomly excited, the modal identification is easier because the stable poles are properly aligned in the natural frequencies. In the case of ambient noise the dynamic identification becomes more complicated due to the appearance of noise poles (stabilization diagrams not shown). The results related to damping tend to show a large scatter and are often unreliable. Still, no correlation was found between damping values using conventional and wireless based systems, with extremely large (and incorrect) values found with the wireless based platforms. Due to the lack of synchronization algorithms implemented for the motes, no information can be gathered on the mode shapes.

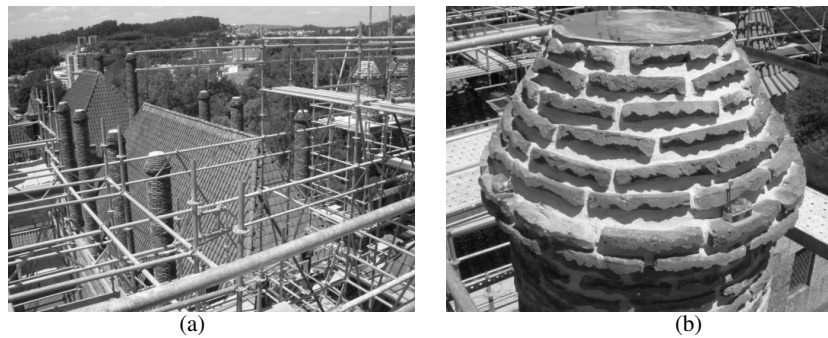
Figure 14: Chimneys at Paço dos Duques: (a) recent conservation works; (b) sensors location.

with one chimney requiring strengthening. Based on the previous results of the experimental tests, the use of commercial wireless platforms for structural dynamic monitoring was again explored. The dynamic response of one of the four original chimneys was studied using conventional and wireless platforms. Figure 14a shows a general view of the conservation works that were carried out and Figure 14b shows the location of the wireless platforms in the experimental tests.

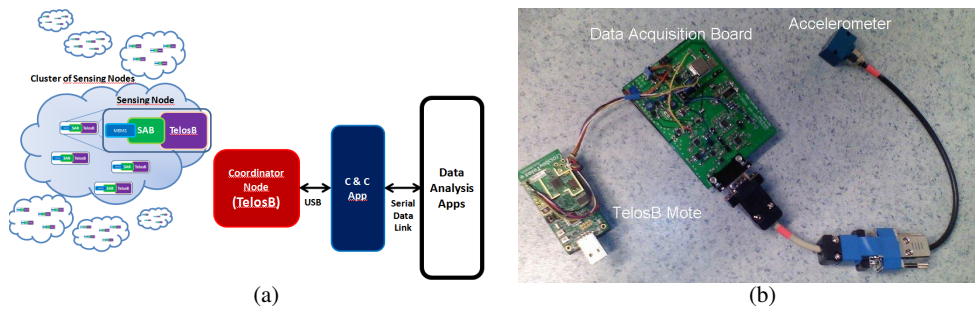
Figure 15: Novel WSN: (a) snapshot of the system architecture; (b) sensing node.

The WSN system architecture is illustrated in Figure 15a. The WSN is composed of several clusters of Sensing Nodes, organized in a cluster-tree topology. Each Sensing Node is composed of a TelosB node, a signal acquisition board and a MEMS acceleration sensor. A small-scale prototype system was conceived with four sensing nodes equal to the one shown in Figure 15b, allowing validation of this solution against a reference wired system. As shown in Figure 16, even for signals with amplitudes below 0.25 mg, the records from the new WSN platform and the conventional wired-based accelerometers presented a remarkable degree of similarity.

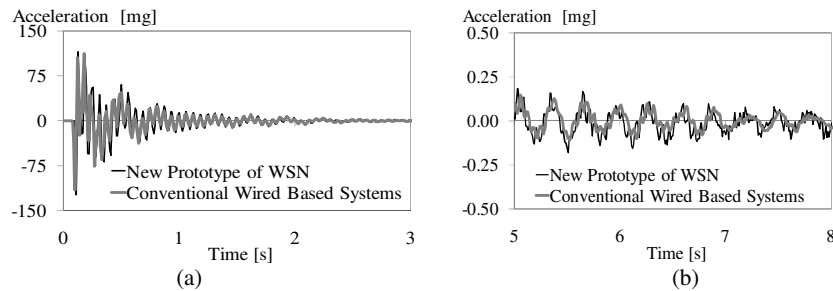
Figure 16: Time domain series: (a) High amplitude excitation recordings; (b) low amplitude excitation recordings.

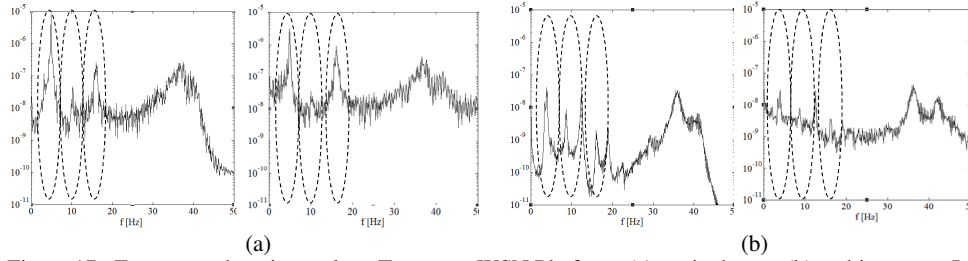
Figure 17: Frequency domain results – Tests new WSN Platform: (a) excited tests; (b) ambient tests. In each figure, left are the wired system results and right are the WSN prototype results.

The next stage consisted on verifying the accuracy of the frequency content of the acquired signals. Considering the same pair of sensors located at the top of the pendulum and 30 s of sampling time, experiments were carried out in two excitation scenarios: random impact (vibrations amplitudes below 5 mg) and ambient noise (vibrations amplitudes below 1.5 mg). The Welch Spectrums of the time series records were calculated and are shown in Figure 17. The results evidenced the high accuracy of the resultant frequency domain spectrums calculated from the records of the new developed system. With this respect, even in the case of ambient noise tests, outstanding similarities in the content of frequencies were detected.

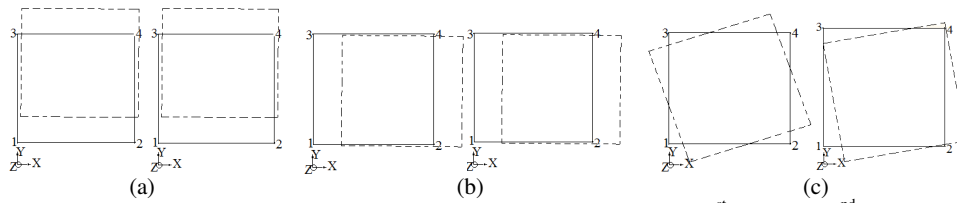
Figure 18: Figure 10. Experimental modal analysis under excited tests: (a) 1st mode; (b) 2nd mode; (c) 3rd mode. In each figure, left are the wired system results and right are the WSN prototype results.

evaluation of the time series recordings with 3 conventional (wired) and 3 new (wireless) sensors located at the top of the pendulum using the SSI method. Figure 18 shows the results of this analysis for the case of random excited system. The first two mode shapes of the structure were identified with no uncertainties, with a difference in measured frequencies about 2%. There was a slight difference in the 3rd mode shape, which needs further investigation.
